# General Aviation Composite Repair

Larry L Mansberger  
*The University of Texas Arlington*  
*Department of Mechanical and Aerospace Engineering*

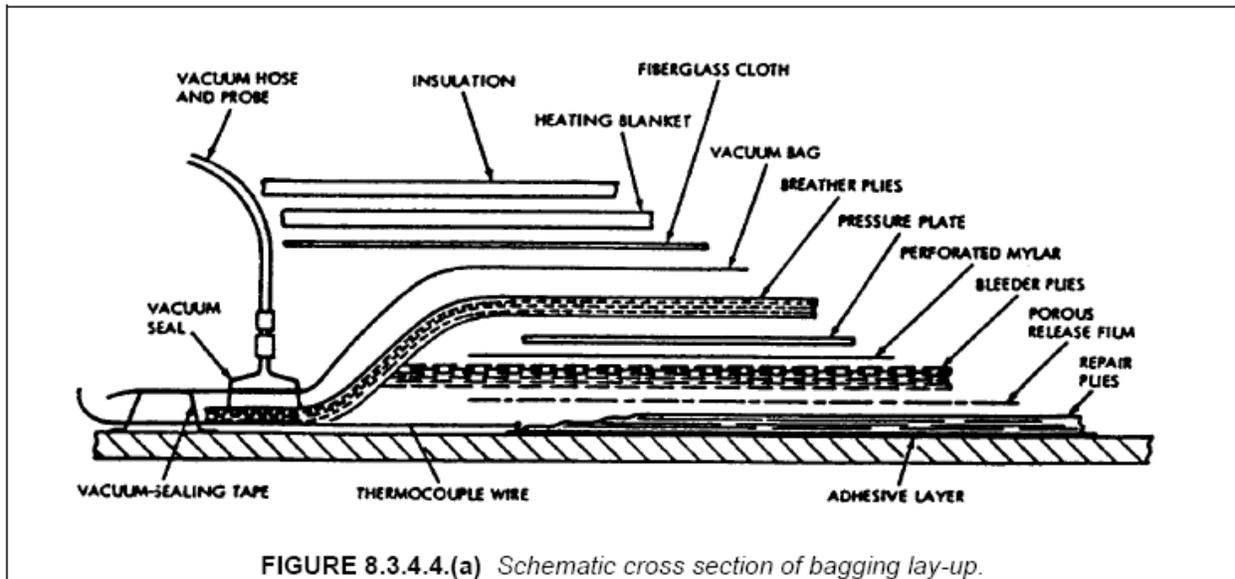
Most repairs specifications will require curing under vacuum induced pressure. A typical vacuum bag schematic is shown in Figure(2) from *MIL-HDBK 17-3F*<sup>3</sup>. The best vacuum bag schedule will vary from one repair lay-up to another. Different repair lay-ups will require different bleeder ply schedules. If the SRM does not call out a precise bagging schematic, it may be necessary to lay-up test panels to determine that the proper amount of resin bleed is achieved. Too much bleed out will cause a weak dry lay-up with high void content, inadequate bleeding or breathing of the bag will cause trapped resin rich areas with uneven fiber volume.

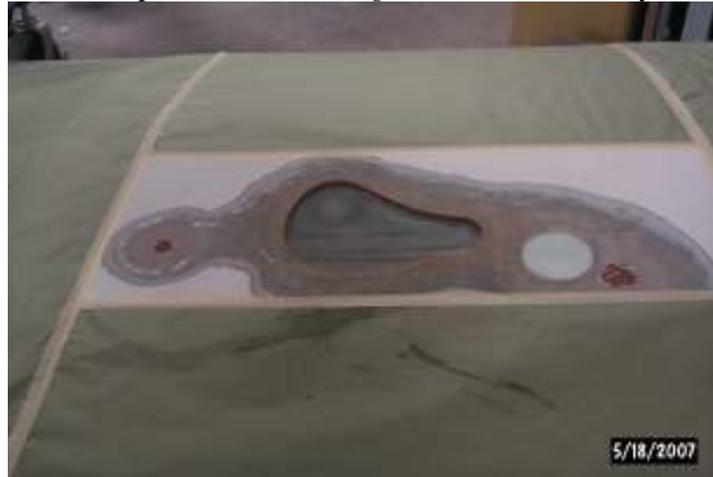
Photo (1) shows the wing skin impact damage with core removed and an external lap repair on the inner skin. The repair laminate was [45/0/0/45/.250 honeycomb/45/45].

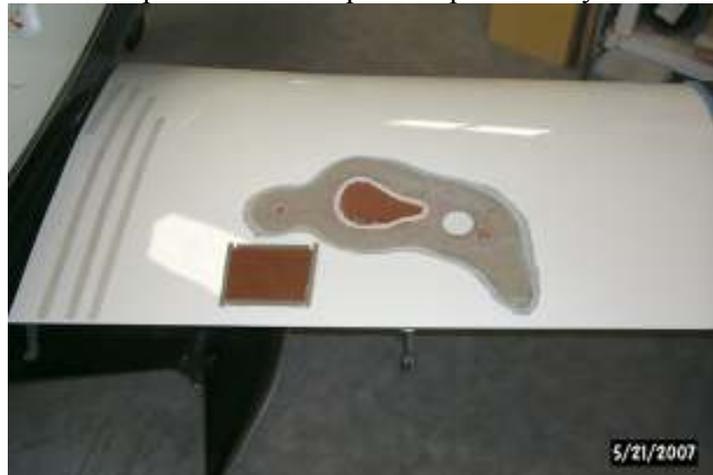
Photo (2) shows core replacement with process panel ready for outer skin lay-up.

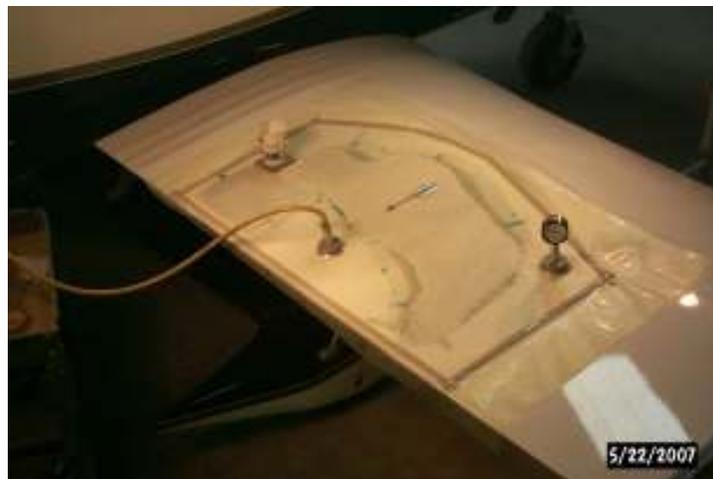
Photo (3) shows the final repair under vacuum. Heat lamps were used for initial cure, followed by post cure at 200°F after removal of vacuum.

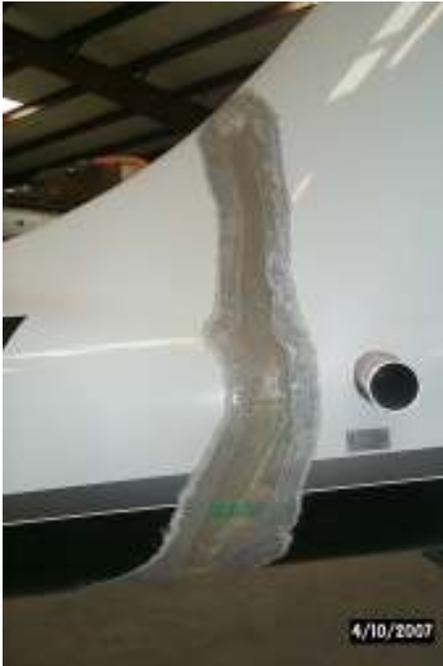
Photo (4) shows the left side of the aft fuselage with the damaged outer skin and honeycomb core removed. The inner skin had only minor damage and remained intact.

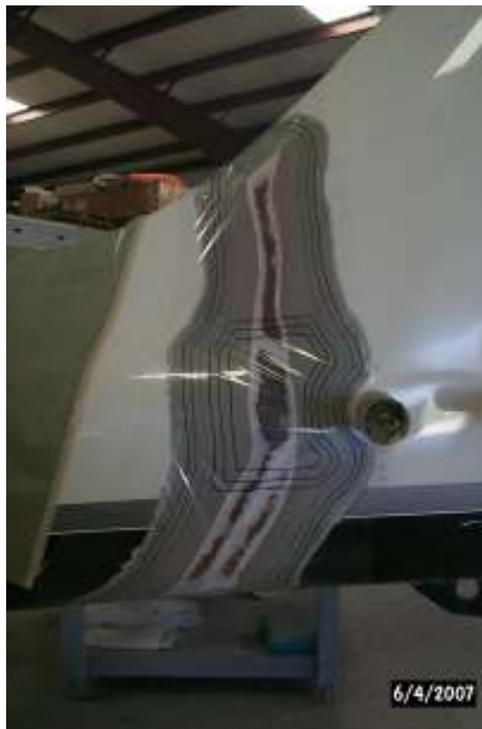
Photo (6) shows the completed scarf mapped out on clear bagging film. This will have fiber orientation marked for use as a cutting template of the individual 7781 plies. The actual repair laminate was [45/0/45], plus an additional localized reinforcement [45/45/45] from 5.5" below to 6.5" above horizontal stabilizer

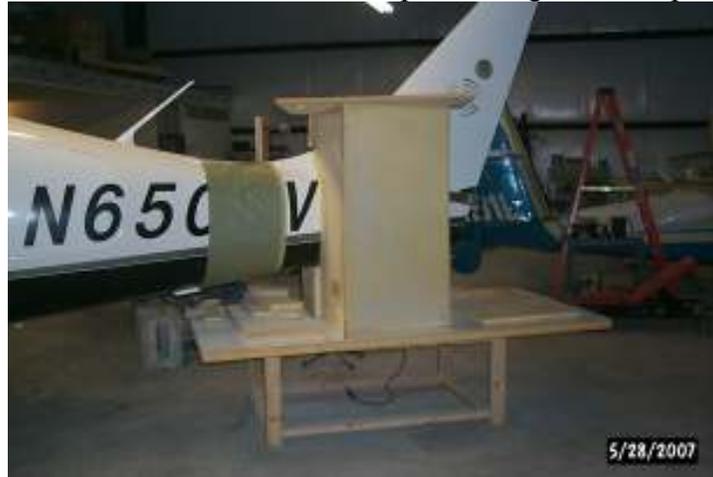
Photo (7) shows one method of building a temporary forced air oven from a high temperature urethane foam box. This was used for post curing the tail repair at 200°F.

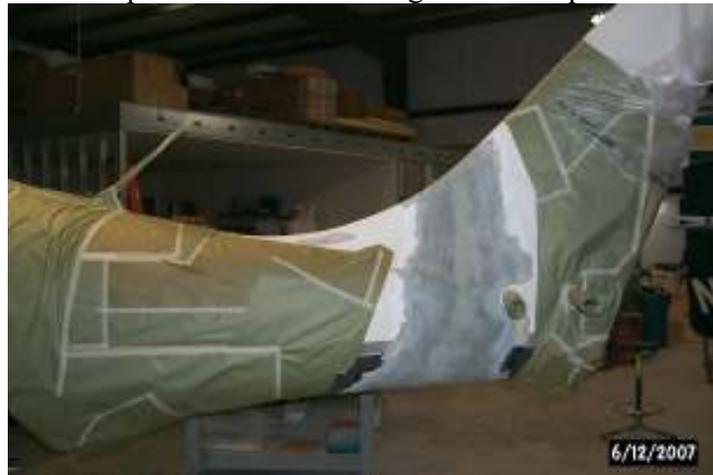
Photo (8) shows the repair after back-scarfing and initial primer surfacer application.

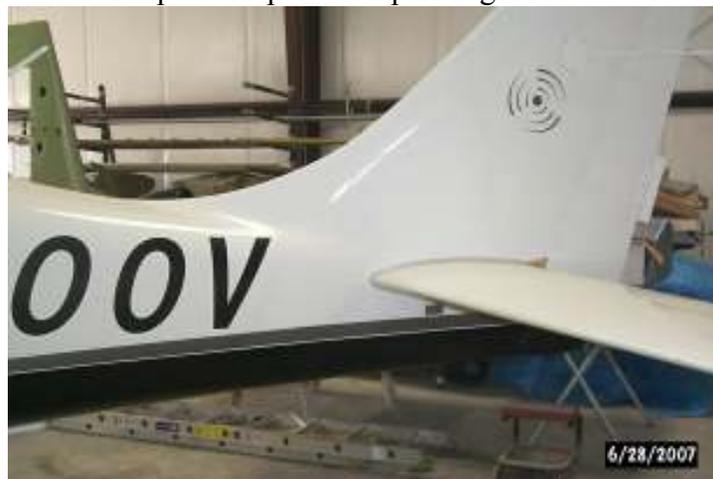
Photo (9) shows the completed repair after painting and reinstallation of stabilizer.
